# MICROSCOPIC EXAMINATION OF STEEL

HENRY FAY, Ph. D., D. Sc.

*Professor of Analytical Chemistry, Massachusetts Institute of Technology  
Consulting Metallurgist, Watertown Arsenal*

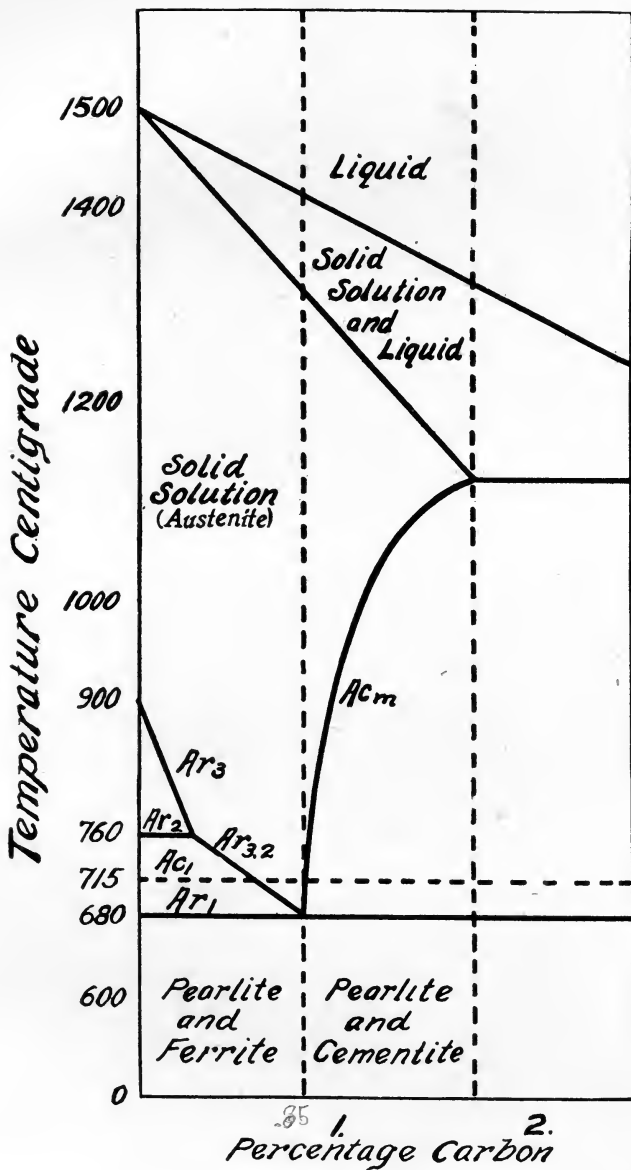
Fig. 1

Portion of iron-carbon diagram

constituents, iron and iron carbide. The  $Ac_1$  point is approximately  $30^\circ$  higher than the  $Ar_1$  point, and represents the beginning of the formation of solid solution. In steels containing 0.85 per cent carbon there is but one critical temperature at which the solid solution decomposes into its constituents, iron and iron carbide. This is known as an eutectoid steel, and its microscopic constituent is pearlite. Pearlite always etches dark, and under high magnifications is shown to consist of alternate laminations of iron and iron carbide. Steels containing less than 0.85 per cent carbon are hypoeutectoid, and contain the microscopic constituents ferrite and pearlite, the amount of the latter increasing with the per cent of carbon. Steels containing more than 0.85 per cent carbon are hypereutectoid, and contain the microscopic constituents cementite (iron carbide,  $Fe_3C$ ) and pearlite. These facts are illustrated in the diagram. (Fig. 1.)

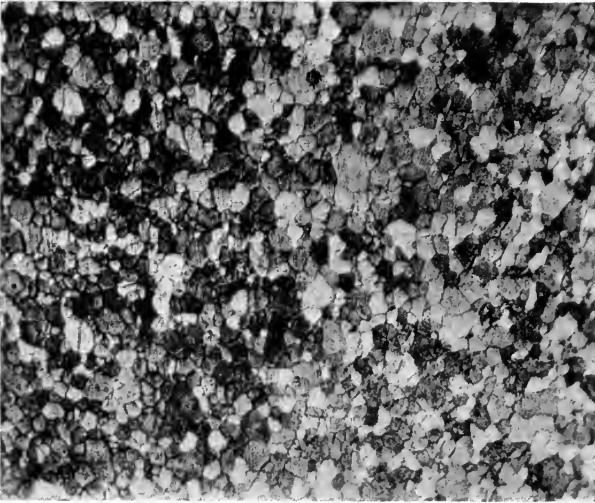
**PHOTOGRAPH NO. 1. X75.**

**0.06% carbon. Approximately pure ferrite.**

Photograph No. 1 shows the characteristics of a carbonless iron in which the whole field is made up of granules of ferrite. With the introduction of carbon there is a decrease in the amount of ferrite and the constituent pearlite begins to appear. This is shown in photograph No. 2 for a steel containing 0.18 per cent carbon. Inasmuch as steels containing 0.85 per cent carbon contain 100 per cent pearlite, and as pearlite is composed of ferrite and cementite, in this steel containing 0.18 per cent carbon there ought to be approximately 20 per cent of the field made up of pearlite. In a steel containing 0.5 per cent carbon there should be 58.8 per cent pearlite. Such a steel is shown in photograph No. 4. A eutectoid steel containing 0.83 per cent carbon and practically 100 per cent pearlite is shown in photograph No. 7. Under higher magnifications pearlite shows the laminated structure shown in photograph No. 8. In hypereutectoid steels the excess carbon beyond that necessary to form pearlite, separates as free cementite and the amount of free cementite can be calculated. Inasmuch as the whole field is made up of pearlite

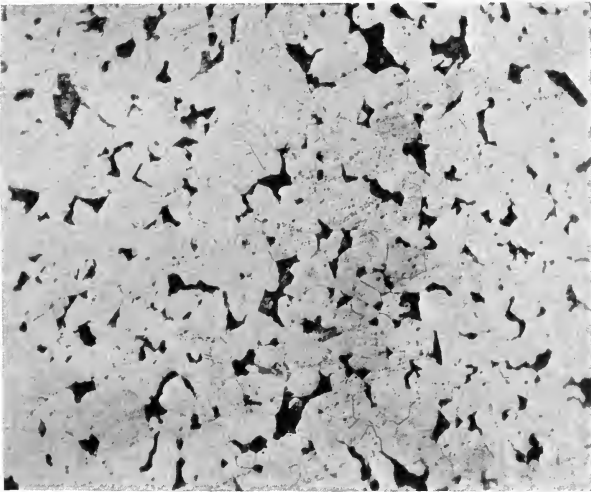
**PHOTOGRAPH NO. 2. X75.**

**0.18% carbon. Ferrite (white) and pearlite (dark).**

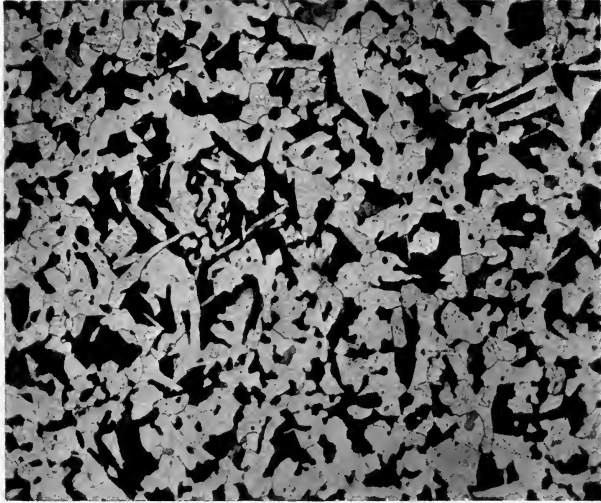
PHOTOGRAPH NO. 3. X75.

0.32% carbon. Ferrite (white) and pearlite (dark).

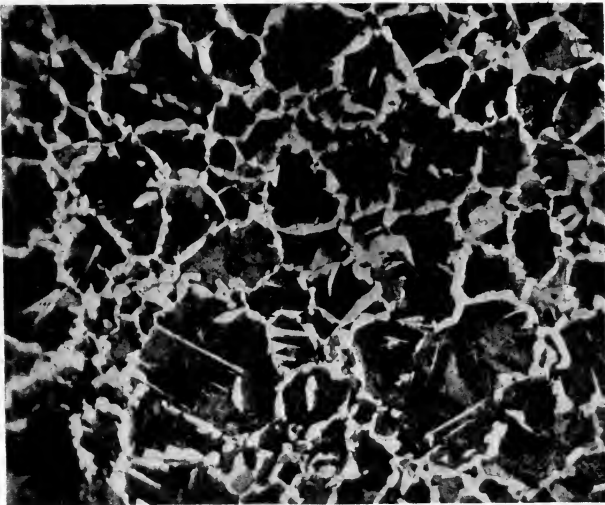
PHOTOGRAPH NO. 4. X75.

0.49% carbon. Ferrite (white) and pearlite (dark).

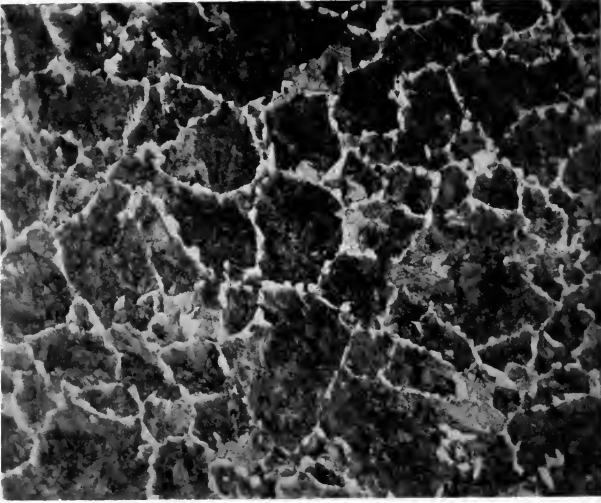
**PHOTOGRAPH NO. 5. X75.**  
**0.57% carbon. Ferrite and pearlite.**

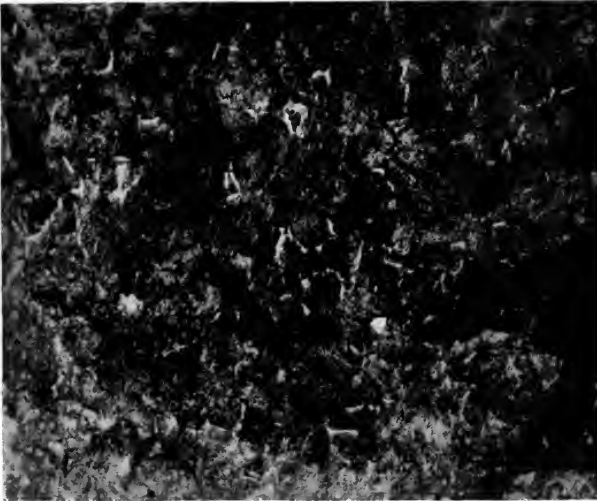
**PHOTOGRAPH NO. 6. X75.**  
**0.71% carbon. Ferrite and pearlite.**

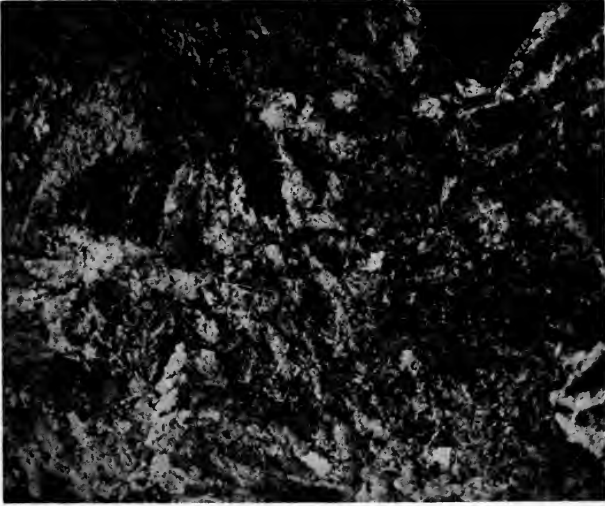
**PHOTOGRAPH NO. 7. X75.**

**0.83% carbon. Pearlite.**

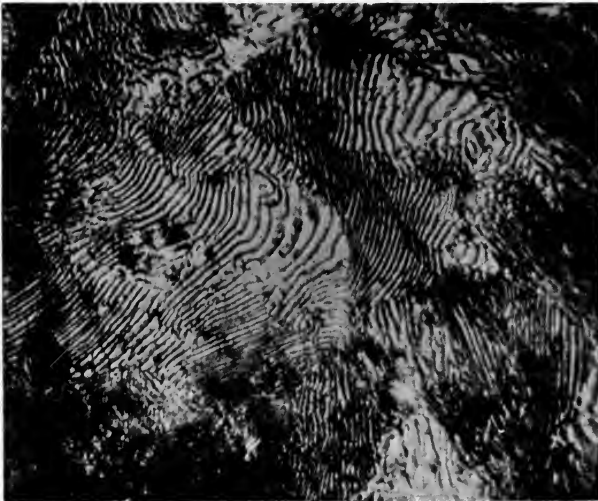
**PHOTOGRAPH NO. 8. X485.**

**0.83% carbon. Pearlite.**

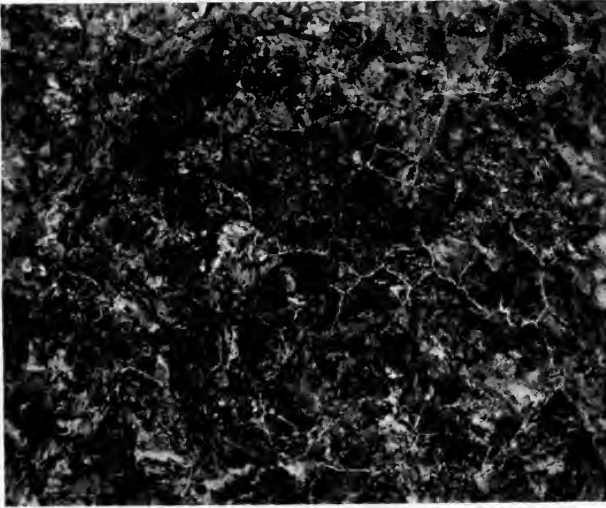
**PHOTOGRAPH NO. 9. X75.**  
**1.22% carbon. Pearlite and cementite (white).**

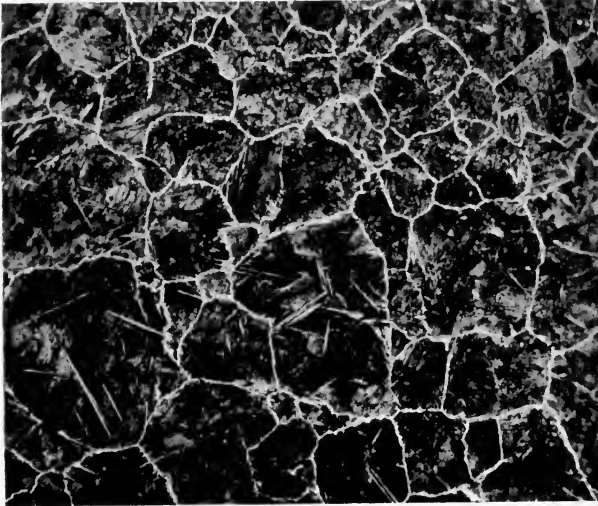
**PHOTOGRAPH NO. 10. X75.**  
**1.46% carbon. Pearlite and cementite (white).**

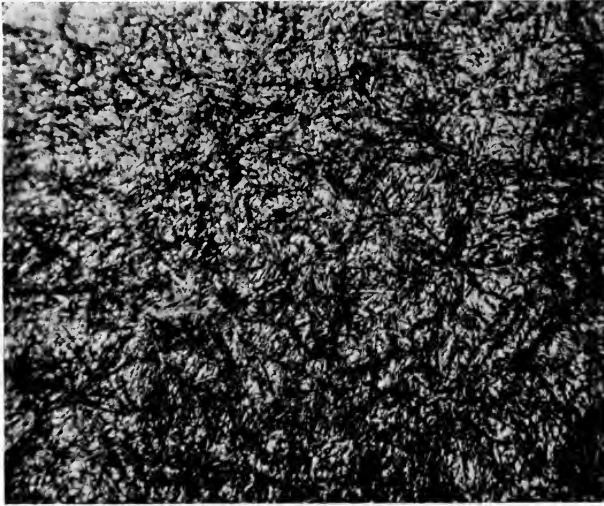
**PHOTOGRAPH NO. II. X75.**

**Martensite.**

Photograph No. 11 shows the characteristic appearance. Commercially martensitic steels are unimportant on account of their extreme brittleness and they are found only rarely.

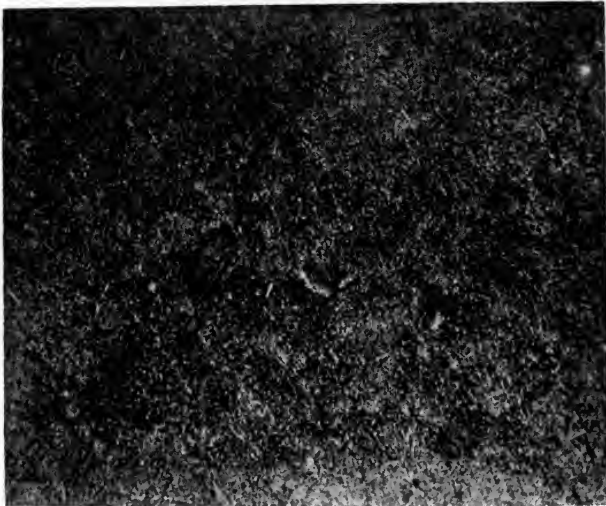
**PHOTOGRAPH NO. 12. X75.**

**Troostite.**

If heated to temperatures below  $A_{c1}$ , the effect produced will vary with the temperature. The lower the temperature of reheating the smaller is the tendency toward stable equilibrium; the higher the temperature the more stable is the product produced. Practically any degree of hardness may be produced, varying from glass-hard to extreme softness, by properly regulating the temperature of the heating. There are then two extremes, the martensitic steels formed by quenching from above  $A_{c1}$  and the pearlitic steels formed by cooling slowly from  $A_{r1}$  or above. Intermediate between these extremes are steels in which more or less of the unstable solid solution has been partly converted to more stable forms. Such forms are represented microscopically by troostite and sorbite. Troostite, formed by tempering at relatively low temperatures, represents the first stage in the breaking down of the unstable equilibrium and is characterized by the amorphous or slightly granular structure. On etching with alcoholic nitric acid the surface usually blackens immediately from separated carbon. Photograph No. 12 shows troostite.

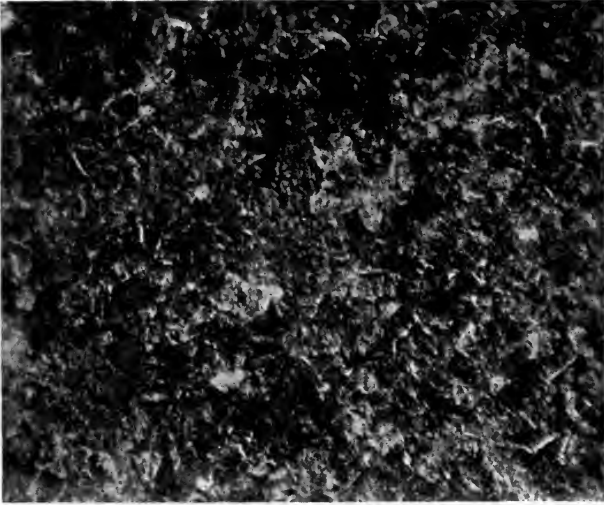
PHOTOGRAPH NO. 13. X75.

Sorbite.

Sorbite steels are those which have been quenched and heated to a higher temperature and thus represent a more stable state of equilibrium. They are characterized by having a peculiar grayish color, and the structure is better defined than troostite. The particles of iron carbide have not assumed definite laminations with ferrite as in pearlite, but are very much more distinct than in troostite. Photograph No. 13 shows sorbite.

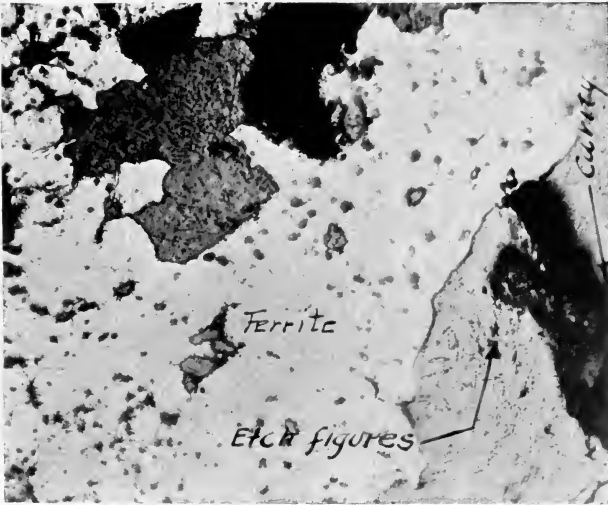
PHOTOGRAPH NO. 14. X50.

Ferrite and massive silicate of manganese. Etch figures in the silicate. (Ferrite, white; silicate, dark.)

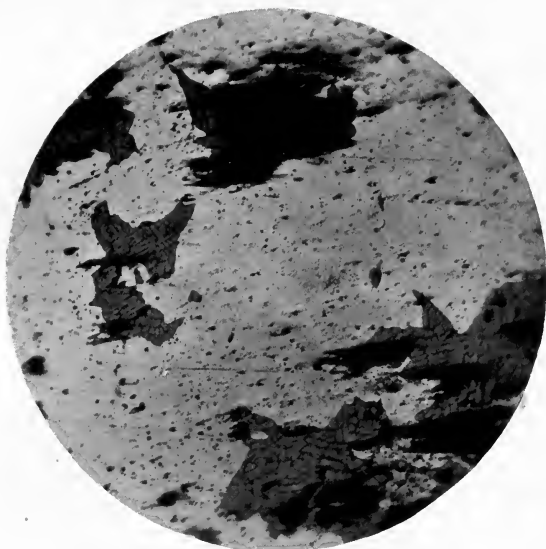
PHOTOGRAPH NO. 15. X50.

Etch figures in silicate of manganese, and cavities due to removal of silicate.

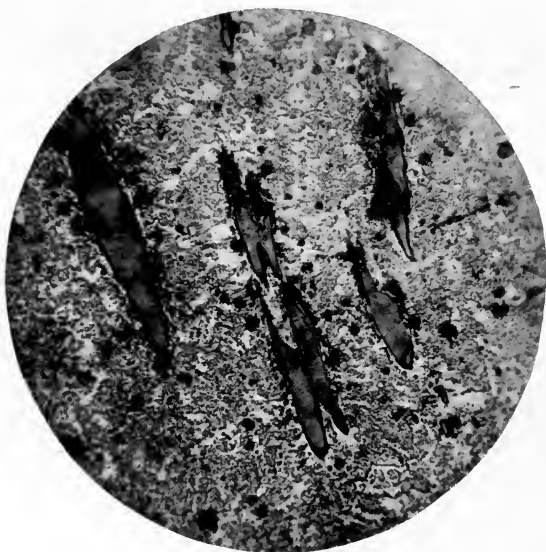
PHOTOGRAPH NO. 16. X50.

Sulphide of manganese in gun steel.

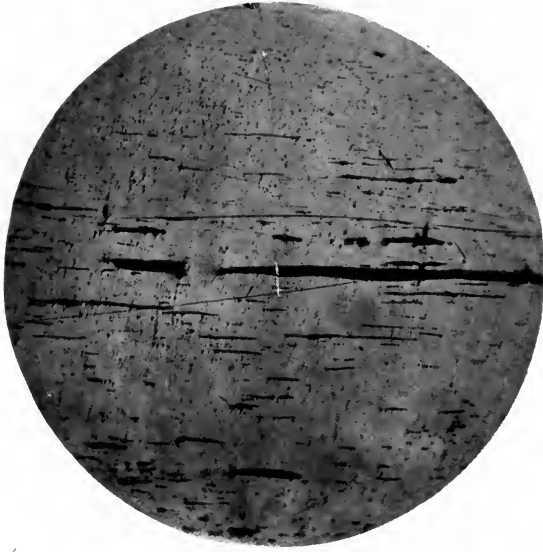
PHOTOGRAPH NO. 17. X50.

Slag elongated in direction of forging. Specimen unetched.

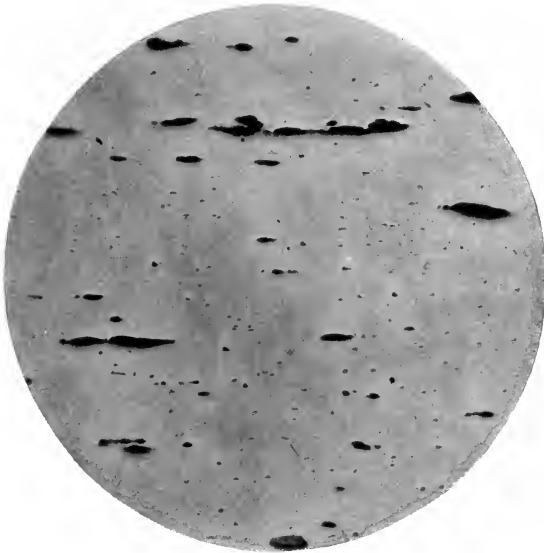
PHOTOGRAPH NO. 18. X50.

Unevenly distributed slag. Specimen unetched.

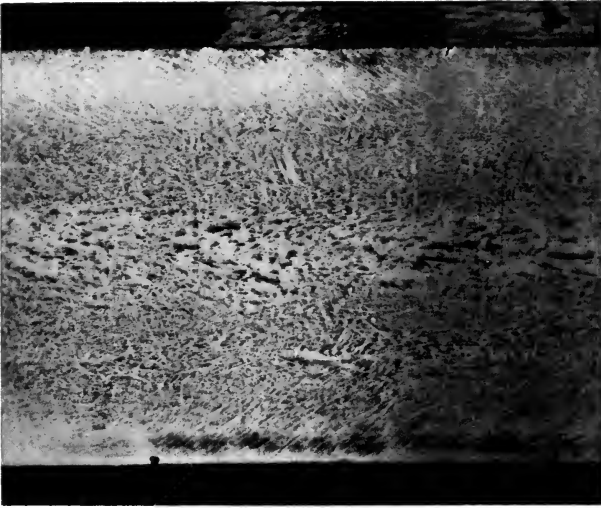
PHOTOGRAPH NO. 19. ONE-THIRD SIZE.  
Ingot structure in steel.

The presence of ingot structure such as shown in photograph No. 19 indicates that the heat treatment and forging have not been sufficient to wipe out the crystallization which occurred on the solidification of the metal. It is not definitely known that the presence of ingot structure is harmful, and it is frequently accompanied by excellent microstructure, but it serves as an indication of the heat treatment to which the metal has been subjected after solidification. It is believed that such a structure would not be found in the best steel, and it is further believed that metal showing ingot structure would be more liable to rupture from shock than metal in which the ingot structure had been wiped out by heat treatment and forging.

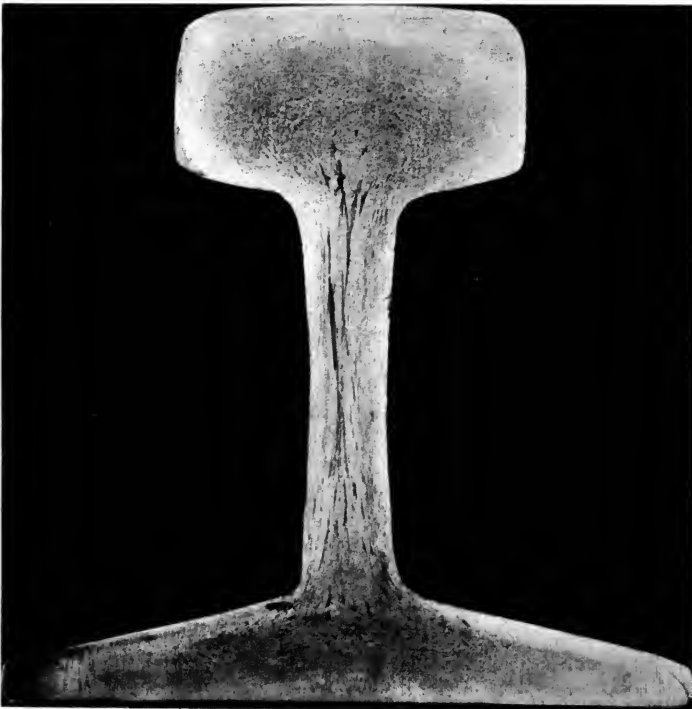
PHOTOGRAPH NO. 20.  
Cross section of steel rail showing segregation in center of head, web, and base.

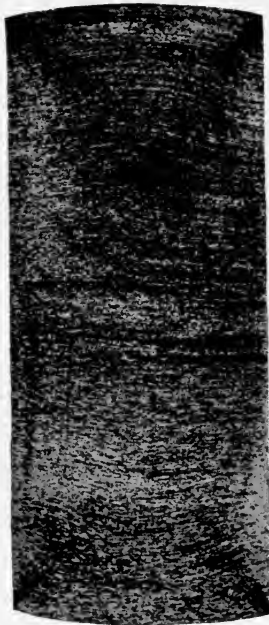
PHOTOGRAPH NO. 23.

Area of strained metal brought out by etching with copper ammonium chloride.

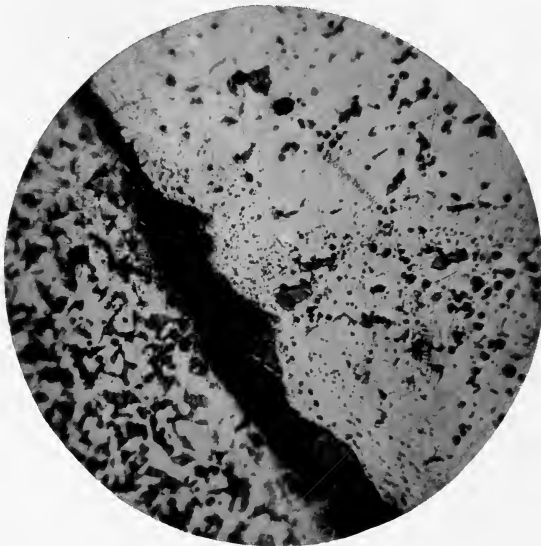
PHOTOGRAPH NO. 24. X50.

Crack, slag, and decarbonized area found on the base of a steel rail.

The inclusion of oxide is frequently accompanied by partial decarbonization, and is most frequently found on or near the surface. An example of this is shown in photograph No. 24, in which it is seen that a crack has penetrated through the slag, probably mill scale, and in the crack are the remnants of the slag. On the left of the crack is the normal structure and on the right is a decarbonized area containing slag. Such an area would probably be large enough to show to the naked eye and would be considered unsafe. Other examples of oxide inclosures are cited on pages 14 and 15, in the discussion of the failure of 10-inch gun and 14-inch gun lever.

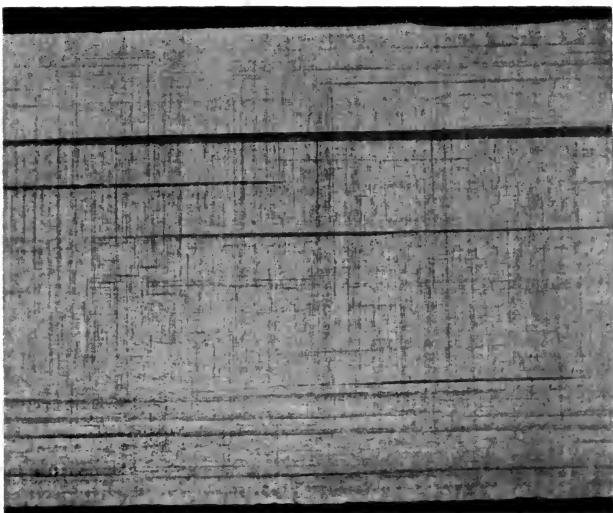
**PHOTOGRAPH NO. 25.**  
**Dark streaks in steel rail.**

Radial test pieces from gun forgings will frequently show streaks, and as the tension is normal to the direction of extension the specimen will show low ductility. Photographs Nos. 25 and 26 show, respectively, dark and light streaks, and photograph No. 27 shows the microstructure of a portion of the light-colored streak with its decarbonization and accompanying slag. (See also Tests of Metals for 1909, vol. 11.)

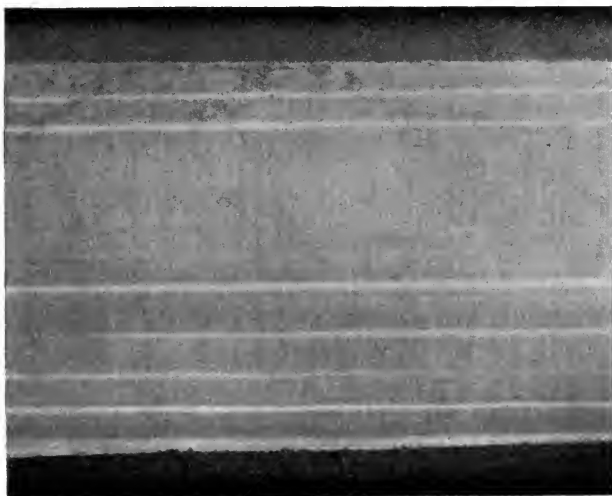
**PHOTOGRAPH NO. 26.**  
**Light streaks in steel rail.**

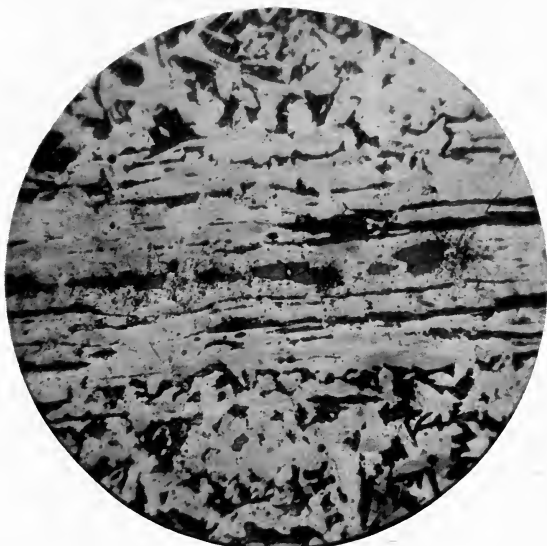
PHOTOGRAPH NO. 27. X50.

Microstructure of light-colored streak in No. 26.

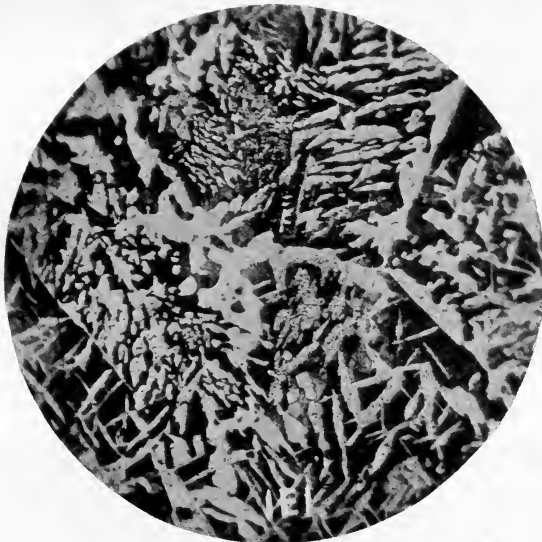
**PHOTOGRAPH NO. 28. X75.**

**Microstructure of cast steel ingot as cast.**

<b>Elastic Limit</b>	<b>39,000</b>
<b>Tensile Strength</b>	<b>77,000</b>
<b>Elongation</b>	<b>10.5</b>
<b>Contraction of Area</b>	<b>16.9</b>

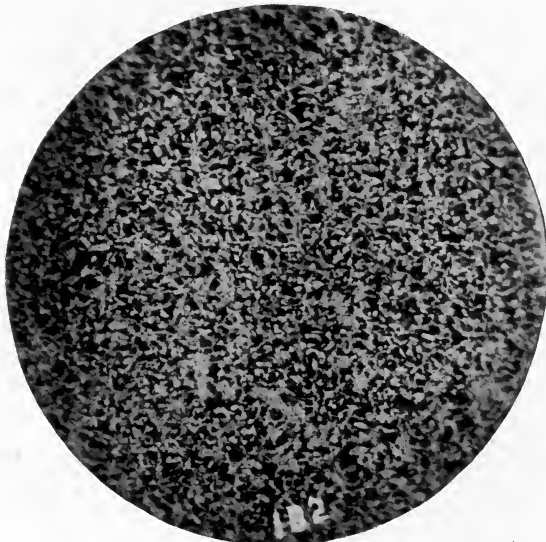
**PHOTOGRAPH NO. 29. X75.**

**Microstructure of cast steel ingot forged to 1450° F. (788° C.)**

<b>Elastic Limit</b>	<b>50,500</b>
<b>Tensile Strength</b>	<b>83,500</b>
<b>Elongation</b>	<b>27.5</b>
<b>Contraction of Area</b>	<b>43.3</b>

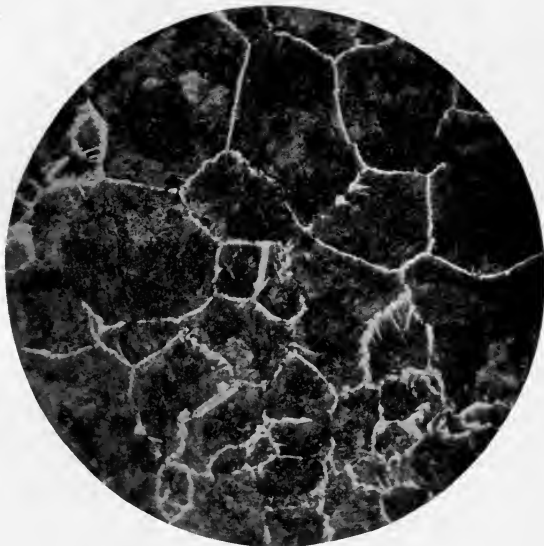
PHOTOGRAPH NO. 30. X75.  
Coarse microstructure in gun steel.

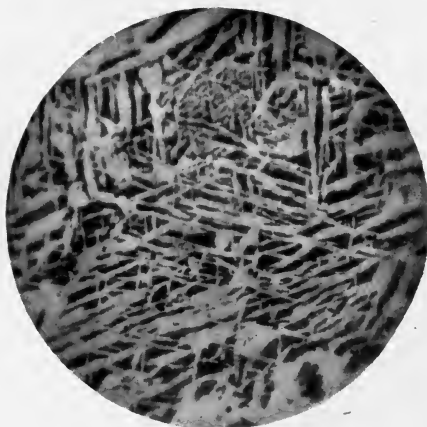
PHOTOGRAPH NO. 31. X50.  
Crystalline structure in cast steel.

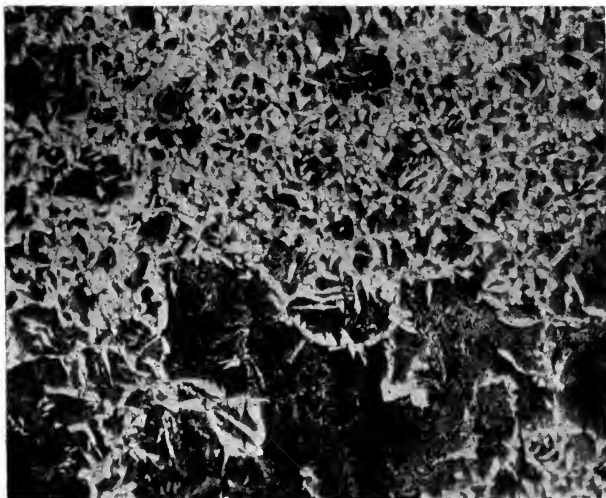
**PHOTOGRAPH NO. 32. X75.**

**Microstructure showing incomplete heat treatment.**

Failure to obtain uniformity of structure is shown in photograph No. 32. Discussion of photographs Nos. 49, 51, and 53 will be found under the discussion of some of the special cases, viz., the failure of 14-inch gun lever arm. Dangerous overheating is shown in photograph No. 33. In this case the material is burnt, as is shown by the oxide between the granules of pearlite.

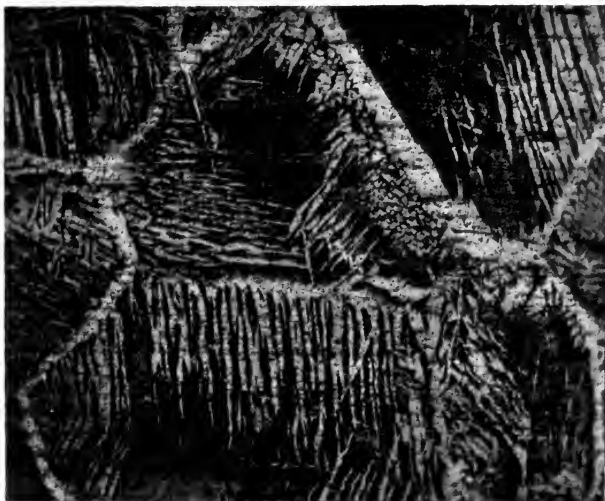
**PHOTOGRAPH NO. 33. X75.**

**Microstructure of overheated steel.**

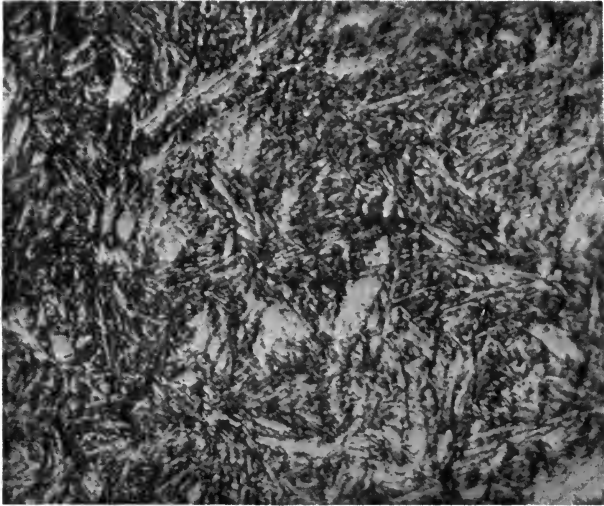
**PHOTOGRAPH NO. 34. X500.**

**Microstructure of forging which had been originally martensitic, and in tempering this structure has not been completely eliminated.**

observed that the original martensitic structure is completely removed by the tempering process. This point is illustrated by photograph No. 34 in which there are distinct remains of the original martensitic structure. Such a steel properly heat treated ought to show a structure similar to photographs Nos. 12 or 13.

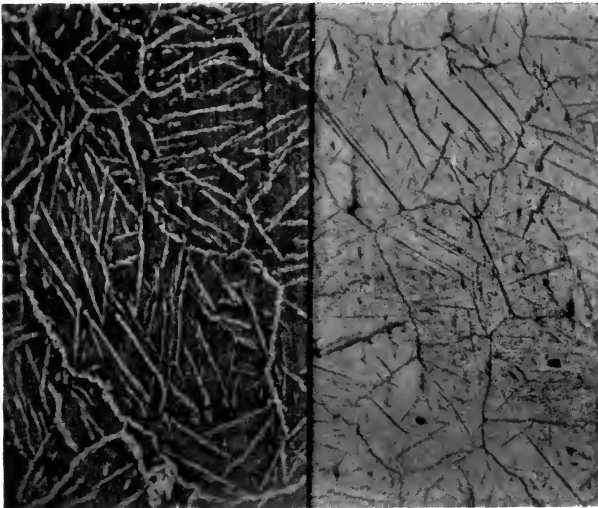
**PHOTOGRAPH NO. 35. X65.**

**Microstructure in center of broken recoil spring showing excess cementite, indicating high carbon. Left, white lines are cementite etched with nitric acid solution; right, dark lines are cementite etched with sodium picrate solution.**

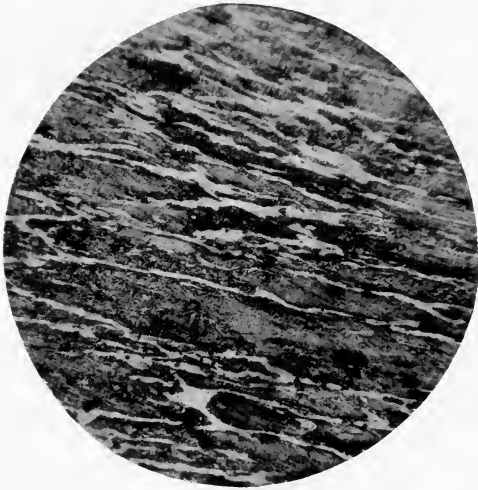
**PHOTOGRAPH NO. 36. X50.**

**Microstructure of steel subjected to cold work, and  
showing distortion of grain.**

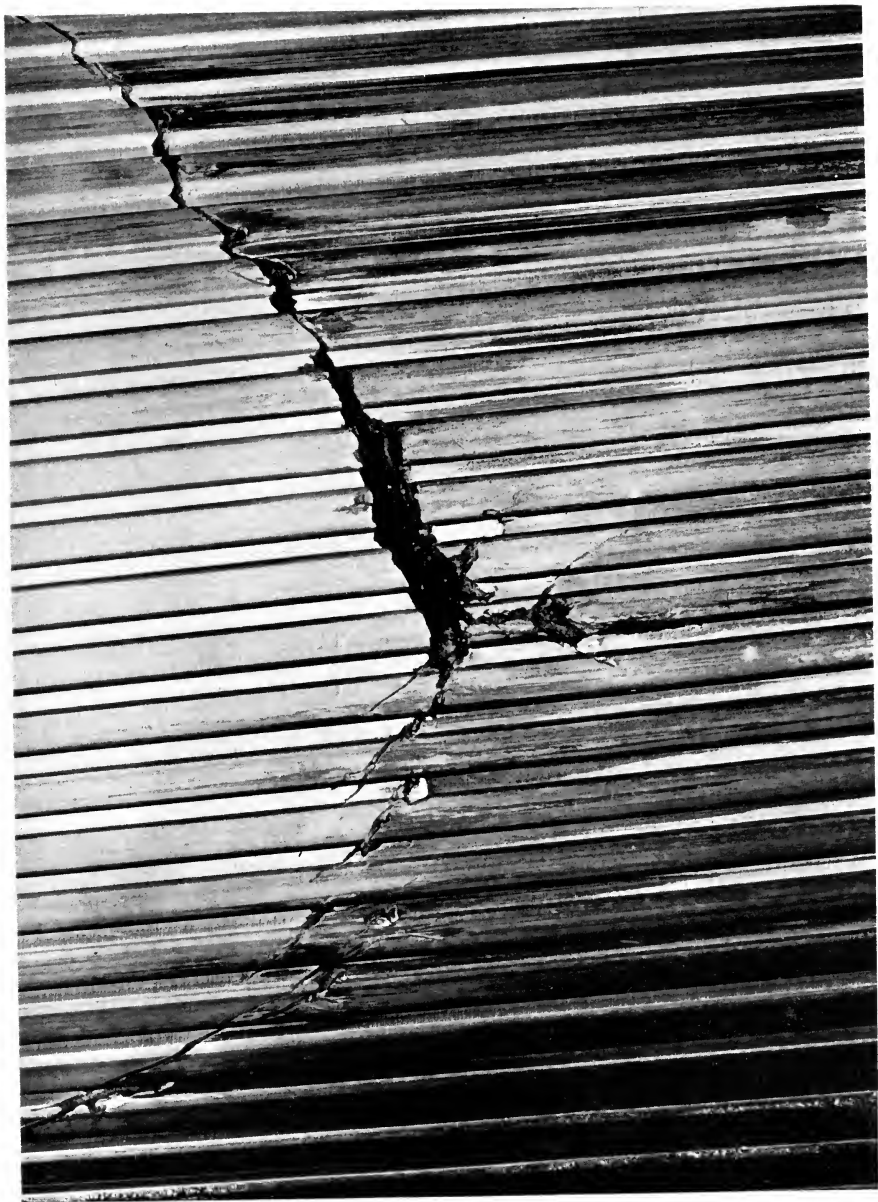
PHOTOGRAPH NO. 37.  
Crack in 10-inch rifle.

The tube of this gun was found to be cracked after proof-firing. The crack was situated about 2 feet in from the breech end and extended in the form of a crescent through a visible distance of about 10 inches. At the central portion of the crack the walls were considerably more separated than at either end, and considerable metal had been removed at this point. The general appearance is shown in photograph No. 37. It will be noted that the crack is not continuous.

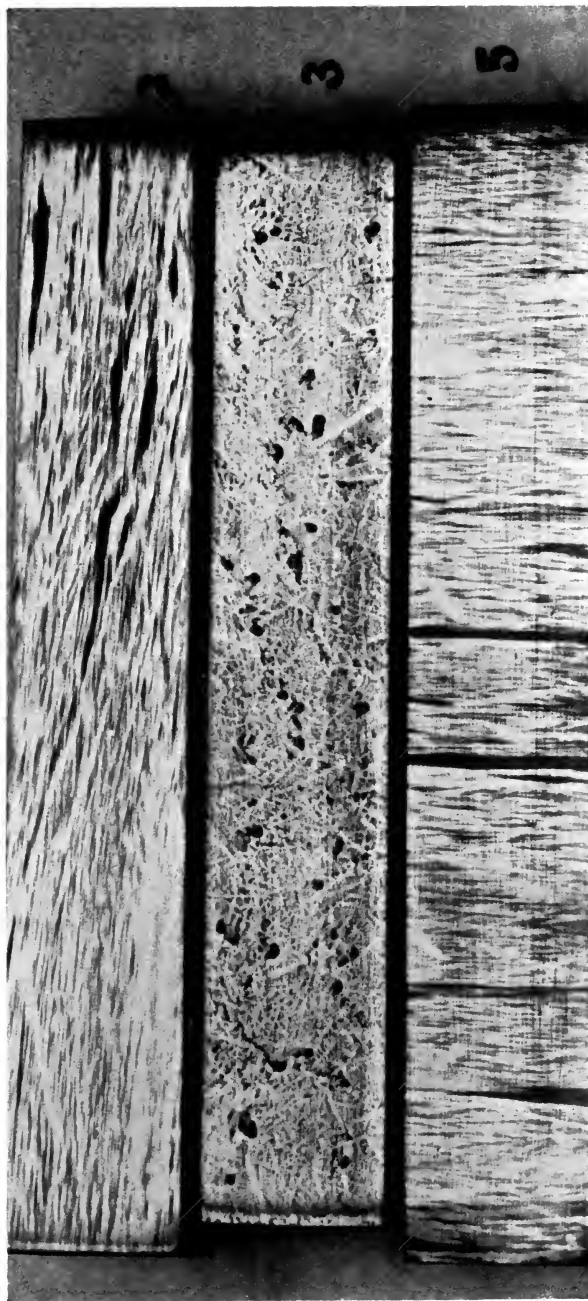
PHOTOGRAPH NO. 38.

Macrostructure of test bars of 10-inch rifle, showing surfaces cut longitudinal (5), radial (3), and tangential (2) to axis.

Photographs Nos. 38 and 39 show the macrostructure of this steel when etched with iodine, the specimens shown in photograph No. 38 being taken longitudinally, radially, and tangentially. The segregation of phosphorus is indicated by the dark lines in pieces Nos. 2 and 5 of photograph No. 38 and in both pieces of photograph No. 39 and by the dark spots in piece No. 3. Photograph No. 39 shows the metal cut from the region of the fracture and treated in the same manner, as shown in test piece marked 5 in photograph No. 38, and in other test pieces not shown. The dark streaks were found to be elongated parallel to the direction of forging, and it is reasonable to suppose that the elongation will always be parallel to the surfaces being forged. By inspection of the two larger pieces of metal cut from the region of the crack (photograph No. 39) it will be seen that there is considerable distortion of the phosphide areas near the

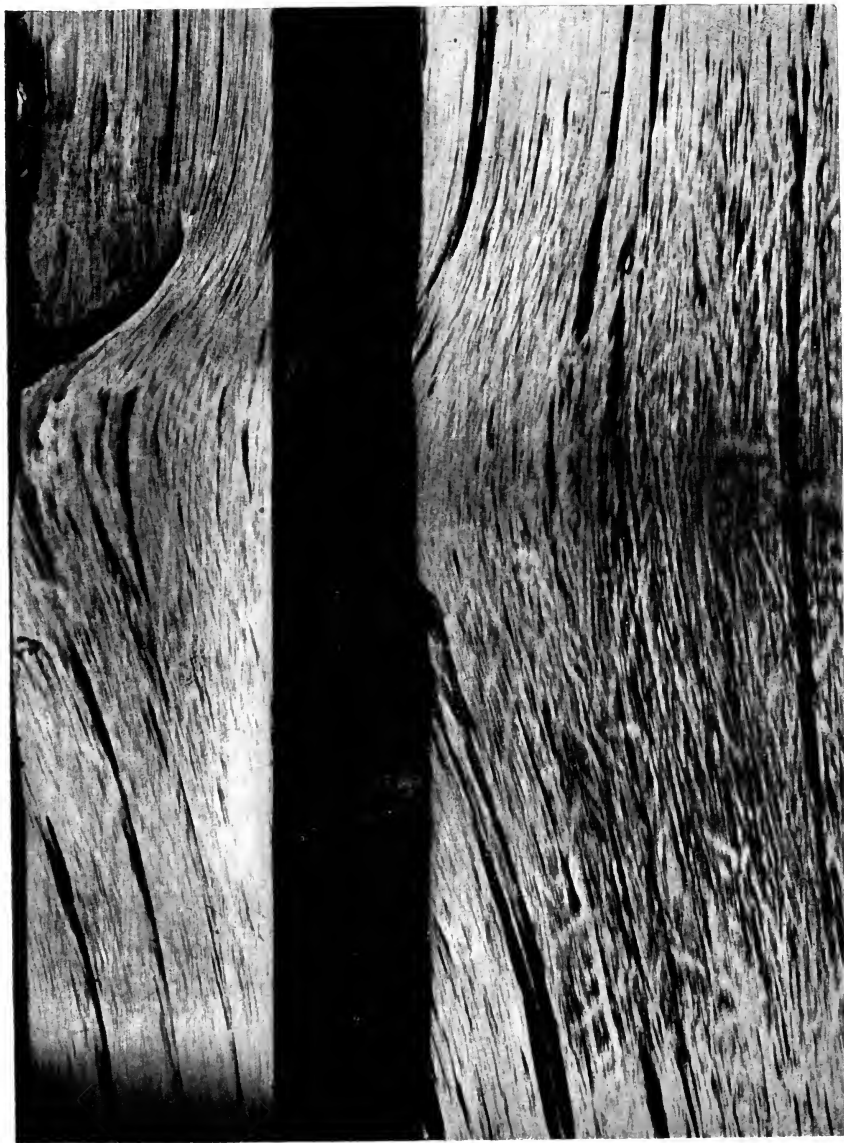
PHOTOGRAPH NO. 39.

Macrostructure in region of crack in 10-inch rifle.

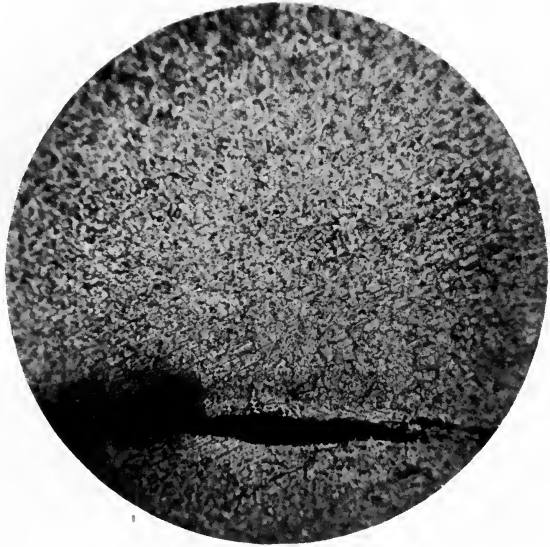
**PHOTOGRAPH NO. 40. X50.**

**Crack and slag, with decarbonized area in 10-inch rifle.**

Examination of sections in the vicinity of the crack showed many fine cracks, slag inclusions, and carbonless areas. The cracks led to slag, and where the slag was found there were also found decarbonized areas. Photograph No. 40 shows a crack ending in slag and surrounded by decarbonized iron. The course of the slag was quite irregular, as shown in photographs Nos. 41 and 42.

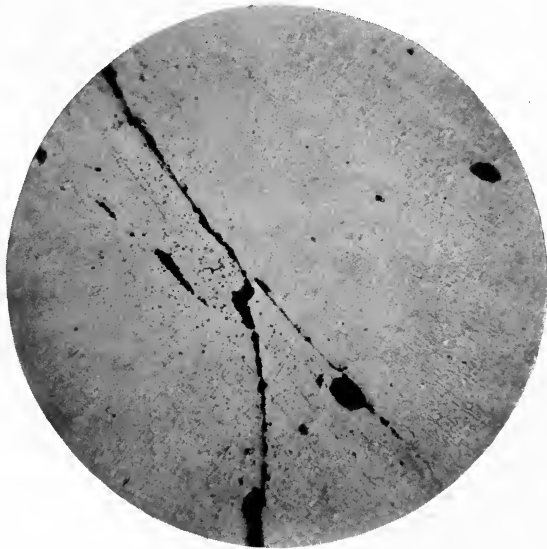
**PHOTOGRAPH NO. 41. X50.**

**Slag in 10-inch rifle, unetched.**

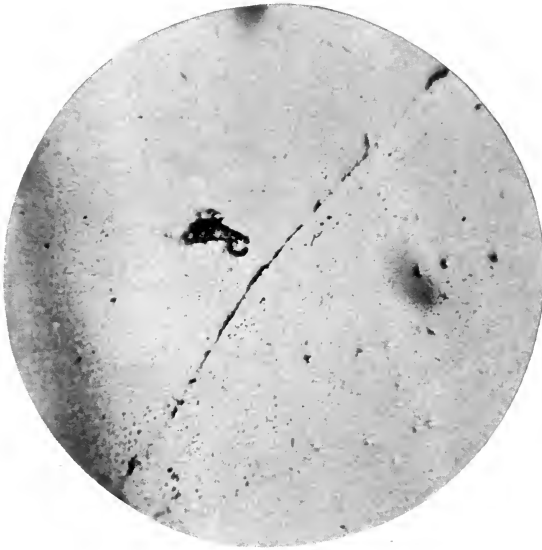
**PHOTOGRAPH NO. 42. X50.**  
**Slag in 10-inch rifle, unetched.**

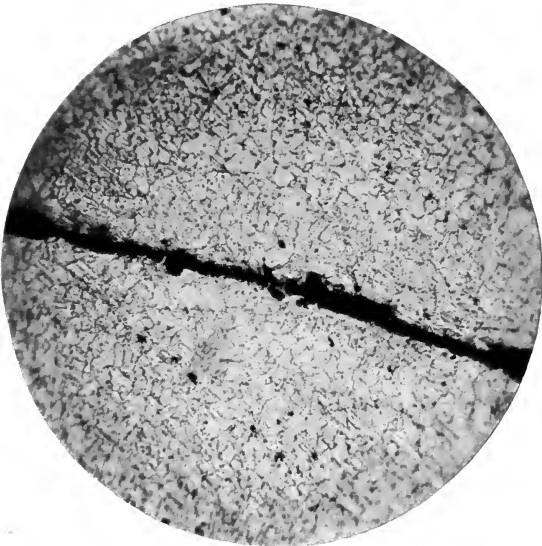
**PHOTOGRAPH NO. 43. X50.**  
**Slag and decarbonized area in 10-inch rifle.**

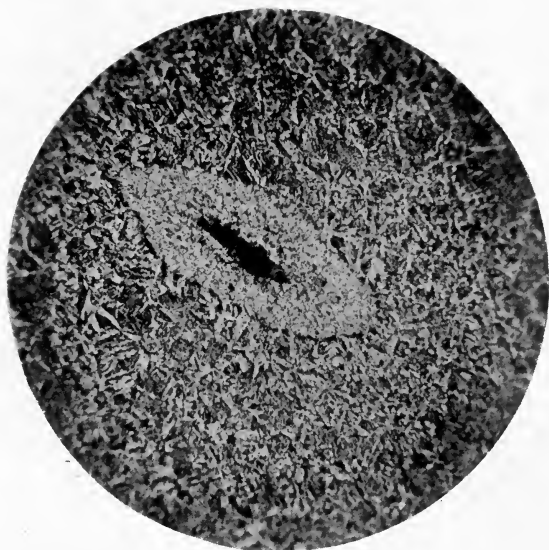
PHOTOGRAPH NO. 44. X50.

Island of slag in decarbonized area in 10-inch rifle.

That the slag originated and was folded into the metal during the process of forging rather than during the manufacture of the steel is indicated by the fact that it is strongly oxidizing in character. If it had originated at the time of making the steel, and had then burned out some of the carbon, there would still have been plenty of time for more carbon to have diffused back into these areas. It is found here, however, surrounded by free ferrite along the slag lines, as shown in photograph No. 43 and in photograph No. 44, in which is shown an isolated slag spot surrounded by free ferrite, and this in turn by the normal structure.

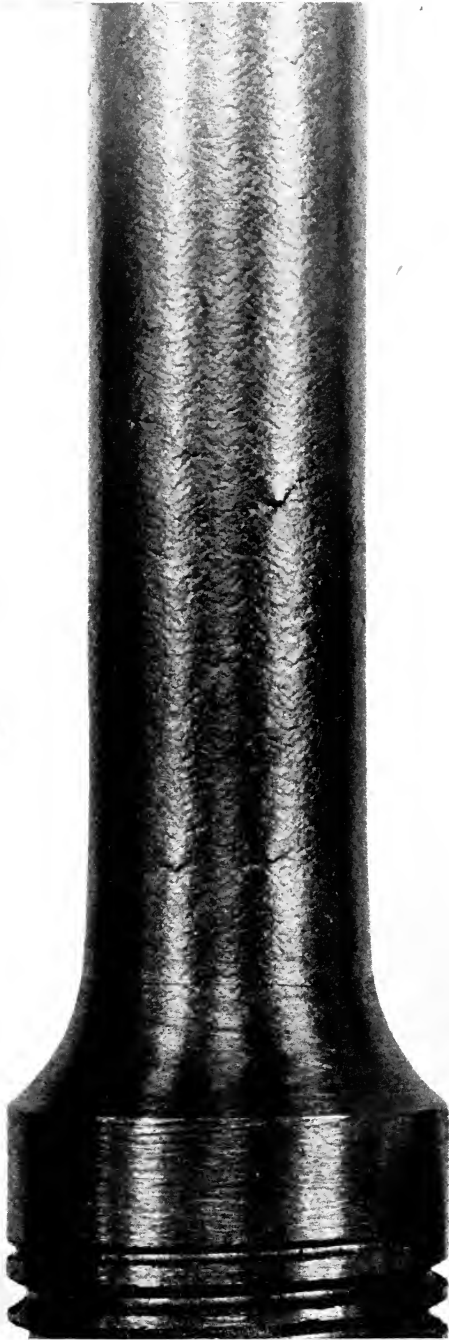
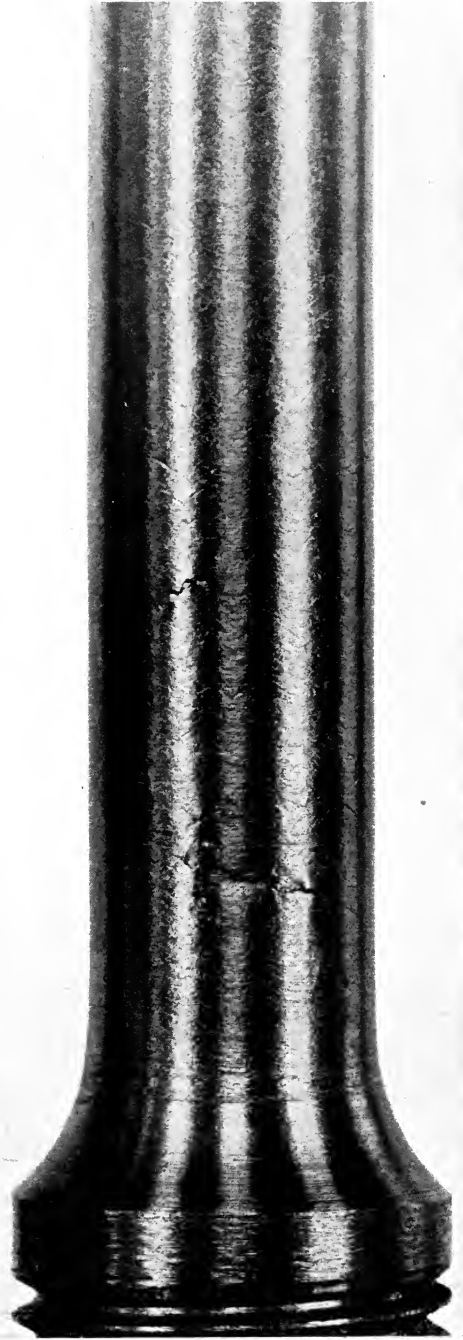
PHOTOGRAPH NO. 45.

Fourteen-inch gun lever test bar specimens showing incipient cracks.

In the fractured ends of the test pieces the metal shows decidedly bright spots, and these are due, it is believed, to the presence of the segregated ferrite. Further, it has been noticed that along the stem of the test pieces incipient cracks are developed, as shown in photograph No. 45. It is highly probable that these incipient fractures are developed in such areas as shown in photograph No. 47, which shows a large ferrite field at the edge of the specimen. It is possible that if the forces are transmitted equally throughout the test piece that such a portion would yield more readily where the carbon was lowest. The strength of such a spot would be approximately that of pure iron, or about 40,000 pounds per square inch, while the darker areas which contain more carbon would show considerably higher values. The presence of much slag in the ferrite areas would also increase the brittleness at this point, and would account for the low ductility in some specimens. Further examples of this form of segregation are shown in photographs Nos. 48 and 49.

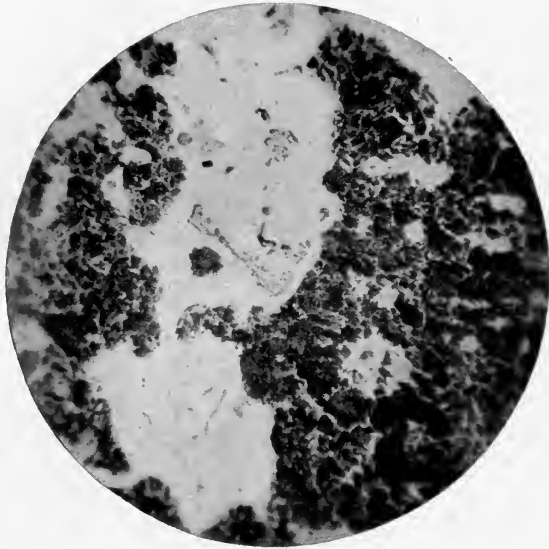
PHOTOGRAPH NO. 46. X50.

Fourteen-inch gun lever. Segregated ferrite (white) with slag inclosures.

This lever was made of cast steel and was broken during the test of the carriage. A microscopic examination revealed the structures shown in photographs Nos. 46 to 51, inclusive.

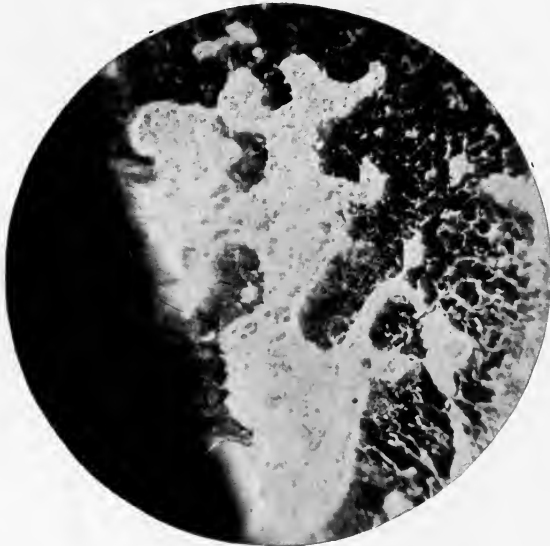
PHOTOGRAPH NO. 47. X50.

Fourteen-inch gun lever. Segregated ferrite on edge of test piece. Slag inclusions.

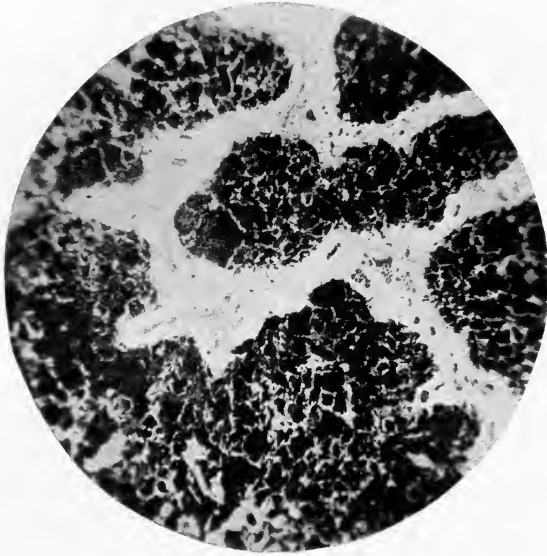
PHOTOGRAPH NO. 48. X50.

Fourteen-inch gun lever. Segregated ferrite (white) with slag inclusions.

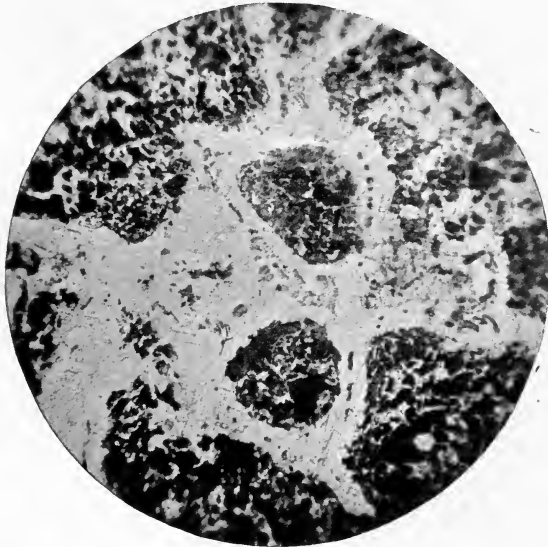
PHOTOGRAPH NO. 49. X50.

Fourteen-inch gun lever. Segregated ferrite with slag inclusions.

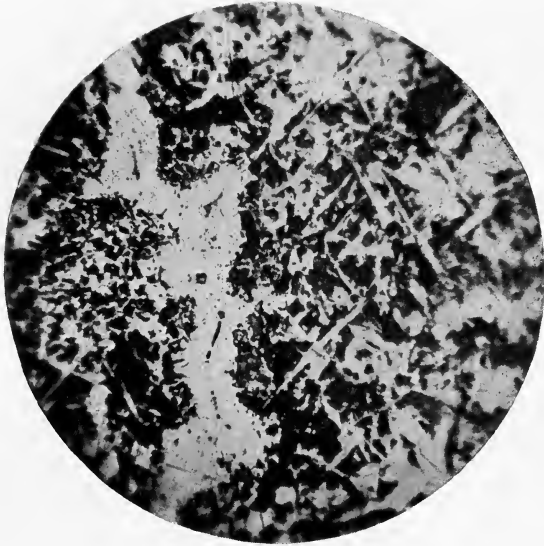
PHOTOGRAPH NO. 50. X50.

Fourteen-inch gun lever. Segregated ferrite and crystalline structure.

The metal has not been annealed in such a way as to remove the original crystallization which took place at the time of solidification. The crystalline structure is shown in photographs Nos. 50 and 51. Proper annealing should have completely wiped out all appearance of this kind. Evidence of this crystalline nature was found in all specimens examined, and it is highly

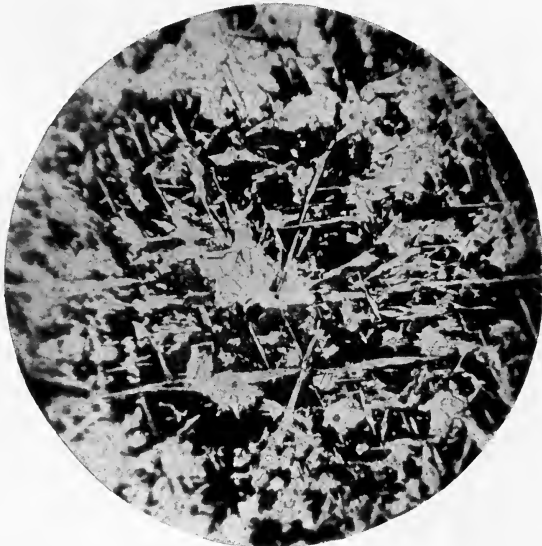
PHOTOGRAPH NO. 51. X50.

Fourteen-inch gun lever. Crystalline structure.

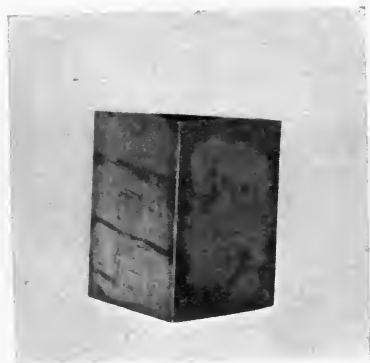
**PHOTOGRAPH NO. 52.**

**Macrostructure of metal removed from 12-inch gun.**

A section of the metal 1 inch square was cut from the region of the fracture, and the macrostructure was developed by etching with iodine solution. Photograph No. 52 shows the macrostructure in which is shown several streaks running parallel to the direction of forging on the left-hand face, and on the right-hand face an irregular area of segregation normal to this surface. Small fissures were visible and both faces indicated the presence of slag. Photograph No. 53 shows the microstructure on the longitudinal face in which is seen slag and small fissures. Photographs Nos. 54 and 55 show an unetched and etched area in the longitudinal face, some of the same slag areas being shown in each, and the lack of homogeneity of the metal is evident.
